AFAPL-TR-69-117

HIGH TEMPERATURE HYDROCARBON FUELS RESEARCH  
IN AN ADVANCED AIRCRAFT FUEL SYSTEM SIMULATOR  
ON FUEL AFFB-12-68

NORTH AMERICAN ROCKWELL CORPORATION/LOS ANGELES DIVISION

FEBRUARY 1970

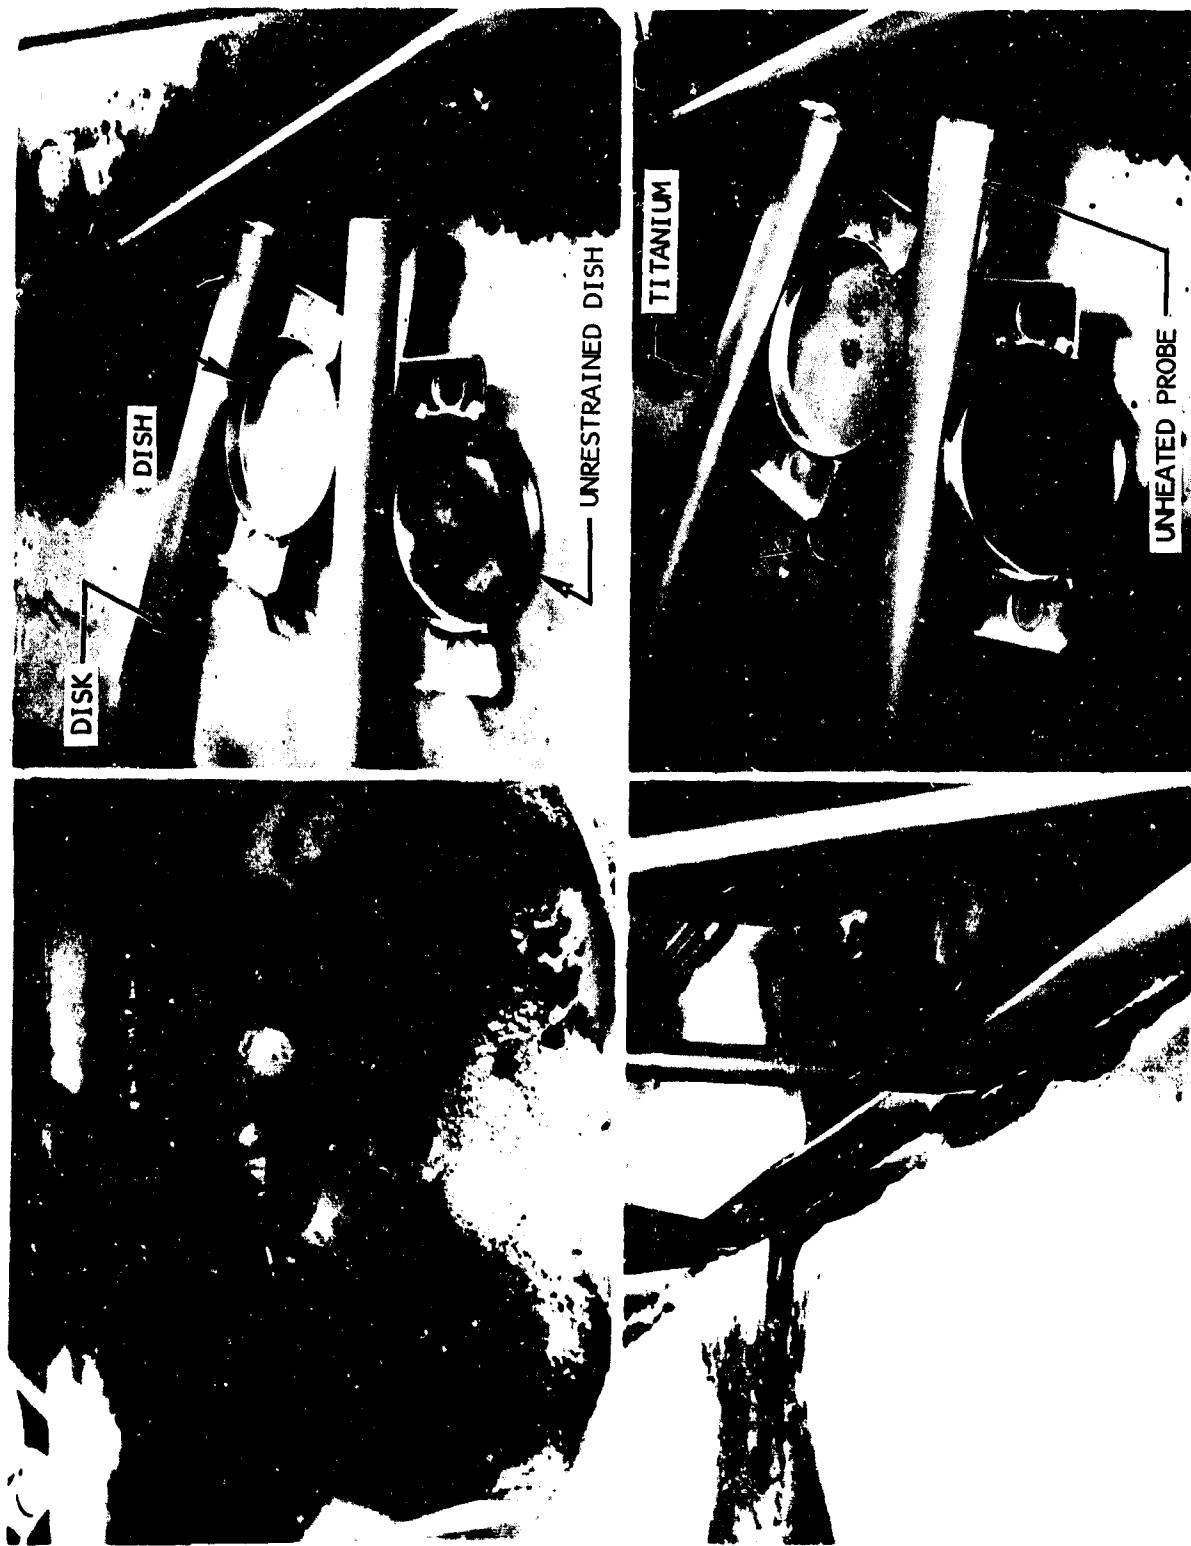
Figure 6. Wing Tank Deposits (5000° F)

It was observed that a very sharp break in deposit color existed between the bottom dry areas (5-6) and the puddle areas (8-9). The puddle areas of the tank were covered with a rough, tightly adhering, glossy-black deposit with numerous loose deposit particles evident throughout the tank and thickest beneath the boost pump. These areas are shown with the dish, disk, and probes in figure 6. Three of the four photographs show the boost pump area, and the lower left photograph shows the opposite end of the tank.

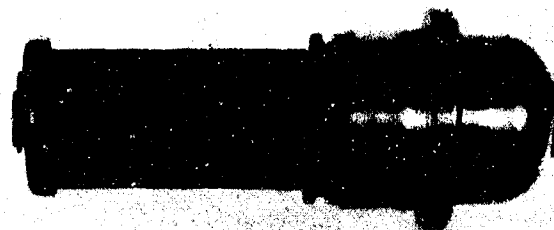
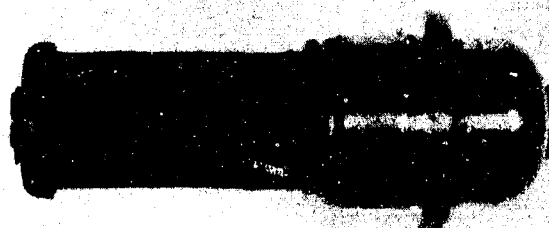
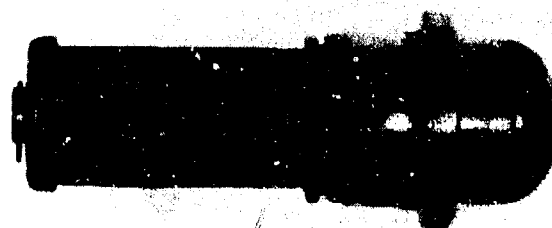
Figure 23. Engine Nozzles

A photograph of the nozzle is shown in figure 23 with a new nozzle. The nozzle screen rated D (AAS Scale) and did not contain any flakes. The deposit on the screen appears as a slight stain and is not thought to be sufficient to affect the nozzle performance.

The pressure drop across the nozzle was measured before and after test 8.801. Based on the results obtained there was a pressure drop increase of 0.8 percent at 2.65 gpm. The nozzle was then dried and inspected. The nozzle screen was slightly stained, rating from a G (AAS Scale) to black, with approximately 75 percent of the screen being black. The support tube was still visible through the screen. A photograph of the nozzle is shown in figure 23 with a new nozzle.

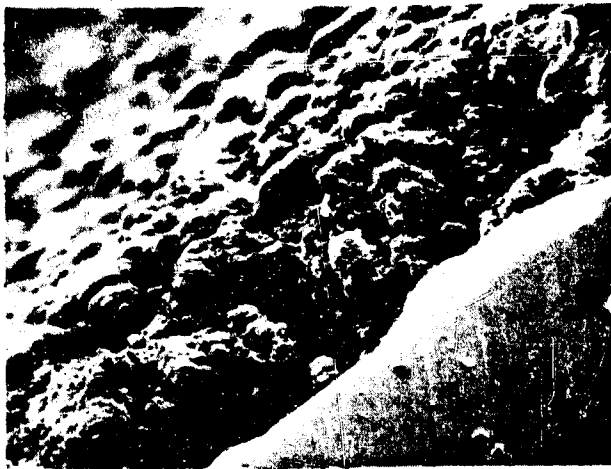
75.8 IN. FROM INLET TAB

MAGNIFICATION 552X  
85-DEGREE ANGLE
